Inspection Report

1234 Main Street

HOMEAuthority

Date: 10/22/2014	Time: 02:00 PM	Report ID: RSmith
Property: 1234 Main Street City, VA 22209	Customer: RSmith	Real Estate Professional: J. Thompson

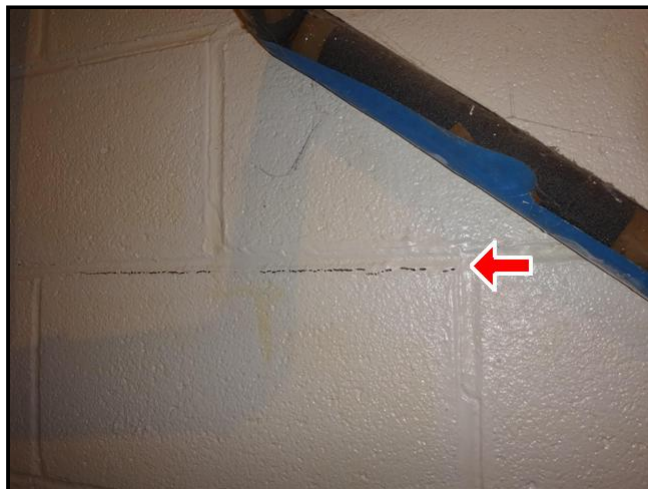
1.0 (Picture 1)

Horizontal cracks in foundation wall are typically caused by hydrostatic pressure - water in the ground pushing against the wall. The house is below street level - improve and maintain surface water controls (Pictures 1, 2)

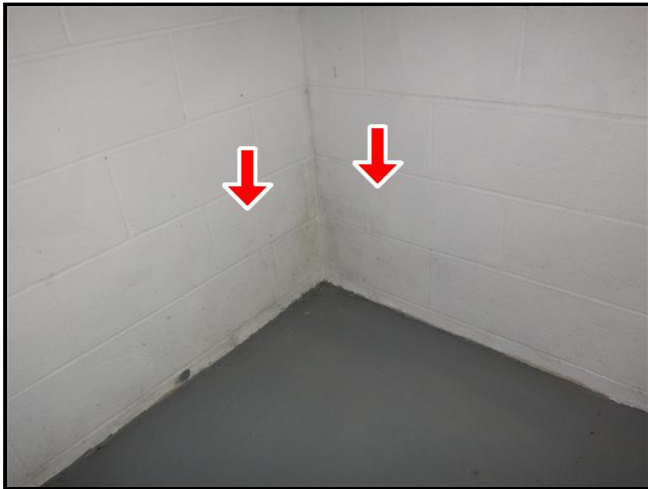
1.2 (Picture 1)

Provide a positive flow of surface water away from foundation walls - efflorescence, peeling paint, stains are all evidence of dampness (Pictures 1 - 4)

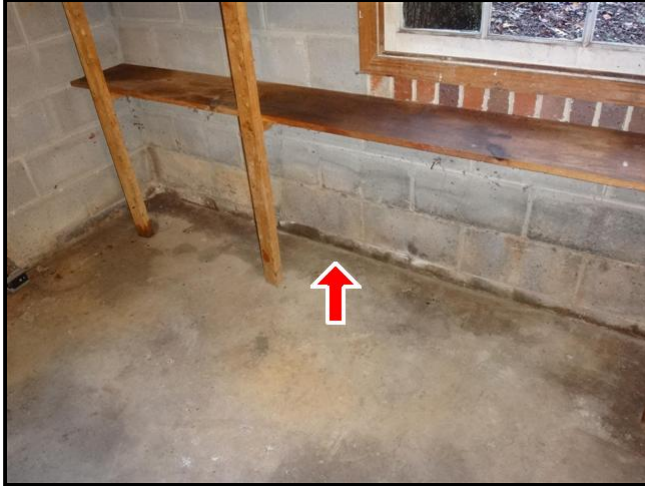
2.5 (Picture 1)

Recommend adding a gutter to the left side of the garage - use oversized gutter (Pictures 1, 2)

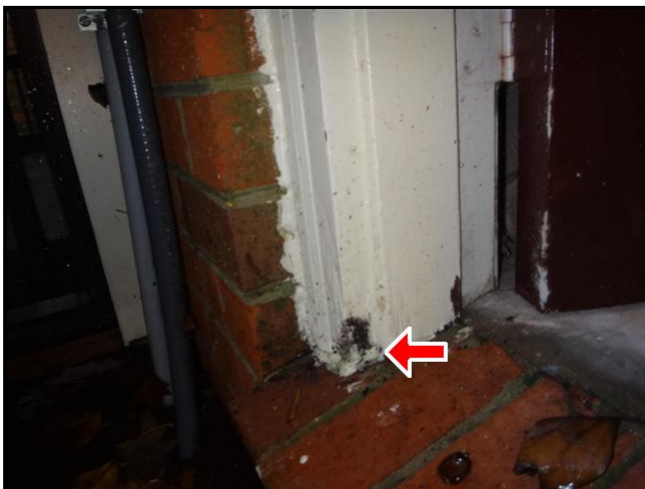
2.9 (Picture 1)

Minor rot at basement door (Pictures 1, 2)

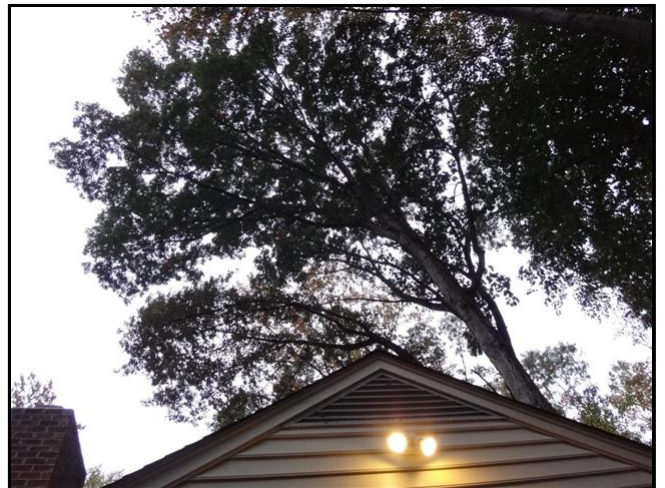
2.15 (Picture 2)

- (1) Have large trees near the house and garage checked by a licensed arborist
- (2) Consider removing the two trees next to the garage - they overhang the garage and house (Pictures 1, 2)

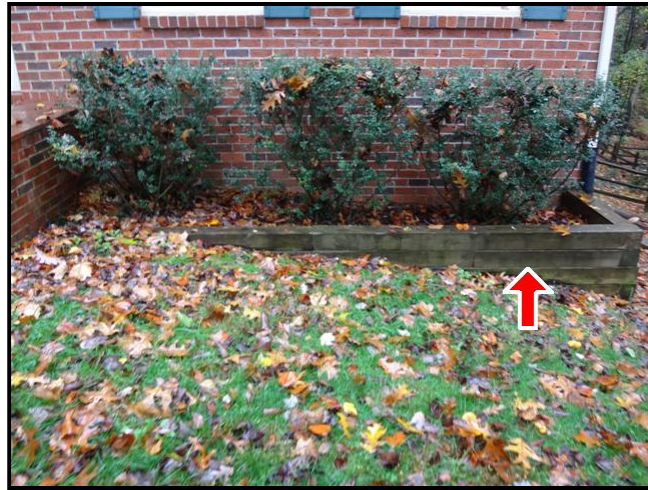
2.16 (Picture 1)

Provide a positive flow of surface water away from foundation walls - ground needs to slope away from foundation with at least an inch of fall per foot for at least eight feet. When this is not possible, install French drain(s) (Picture 1)

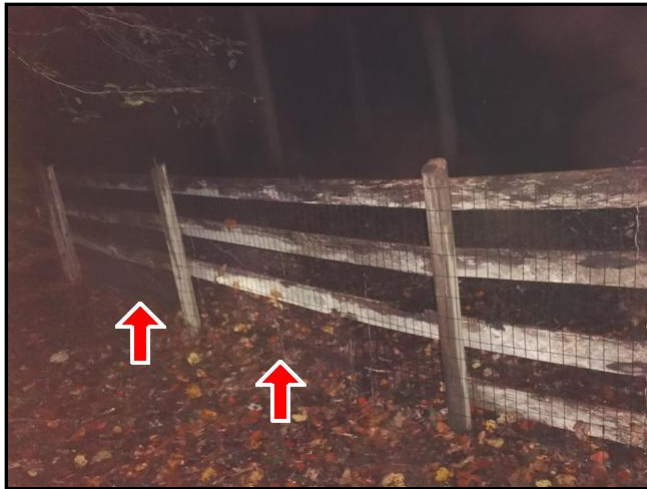
2.17 (Picture 1)

Fence needs repairs - budget to replace (Pictures 1, 2)

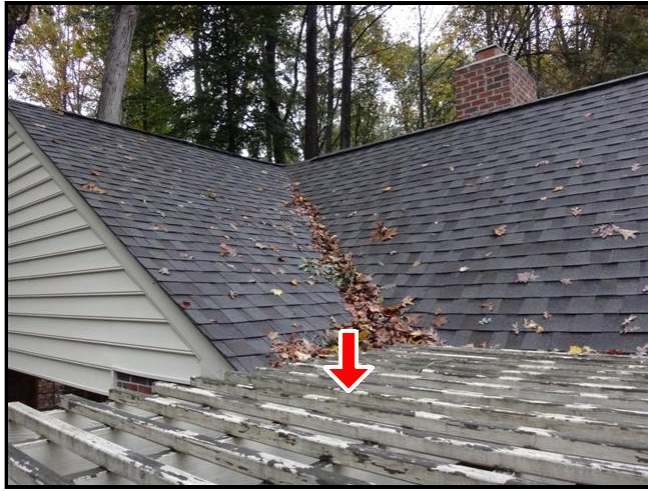
2.24 (Picture 1)

Keep top of pergola painted to prevent deterioration (Pictures 1 - 3)

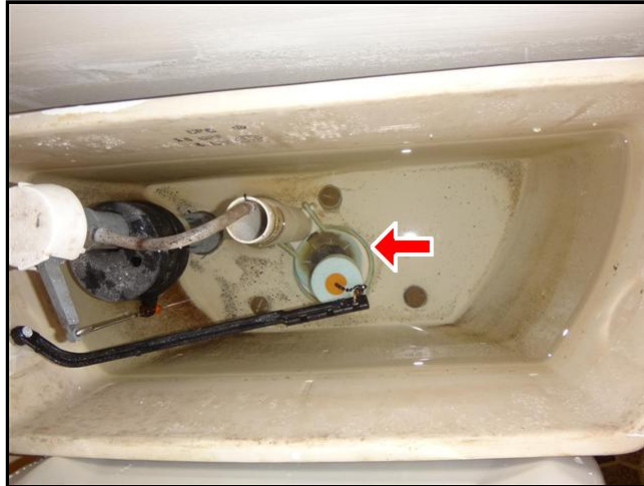
3.2 (Picture 1)

Basement toilet runs - replace tank flapper (Picture 1)

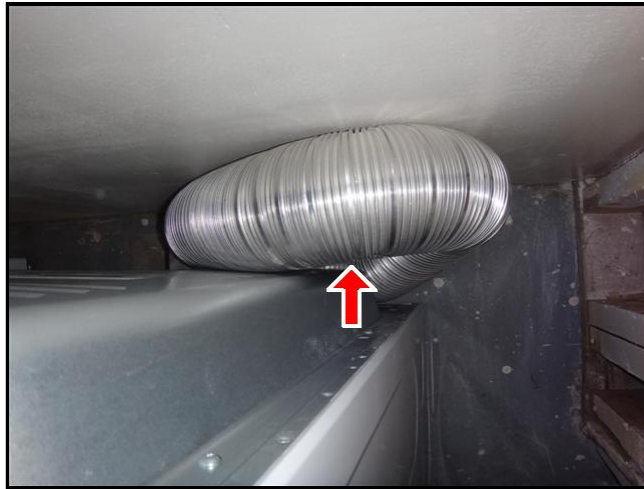
3.6 (Picture 1)

Dryers, vent ducts and vent outlets must be professionally cleaned periodically - fire hazard (Picture 1)

Although flexible metal pipe is approved, it is not preferred - recommend replacing with solid aluminum dryer vent pipe - always use the shortest possible amount of pipe with the fewest possible turns and bends (Picture 1)

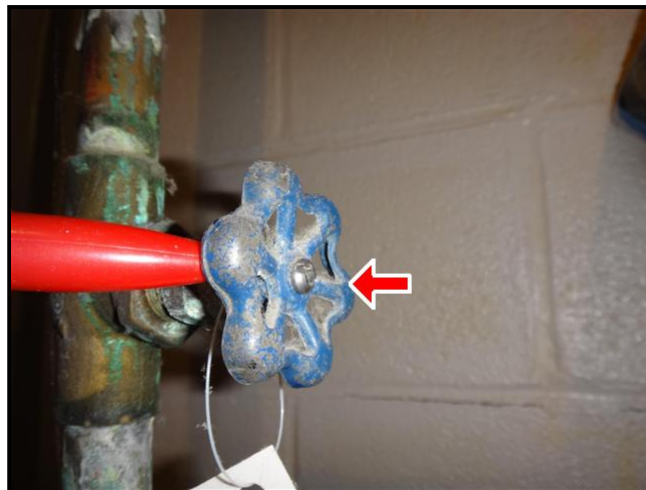
3.10 (Picture 1)

Water heater valve is seized - replace with a ball/90 degree valve (Picture 1)

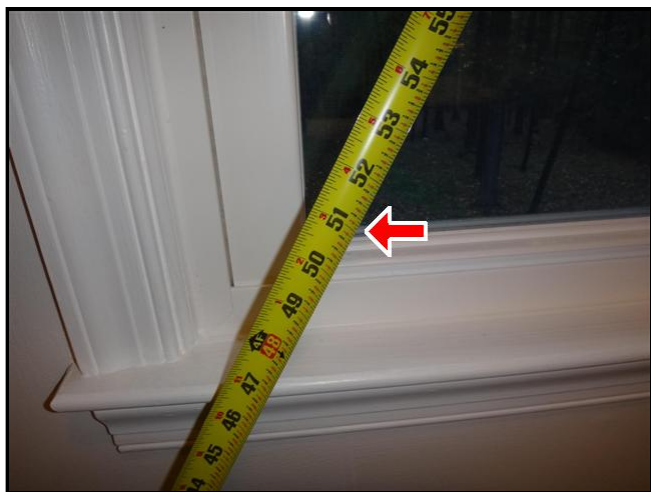
3.18 (Picture 1)

Windows in both main and upper level bathrooms need to be replaced with tempered/safety glass - both windows are within 60 inches of the tub and shower floors (Pictures 1, 2)

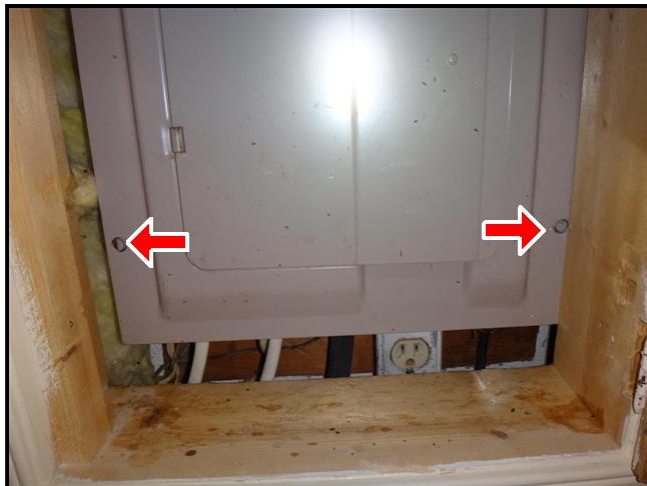
4.1 (Picture 1)

Panel cover screw(s) missing - replace only with manufacturer specific blunt tipped screw(s) (Pictures 1, 2)

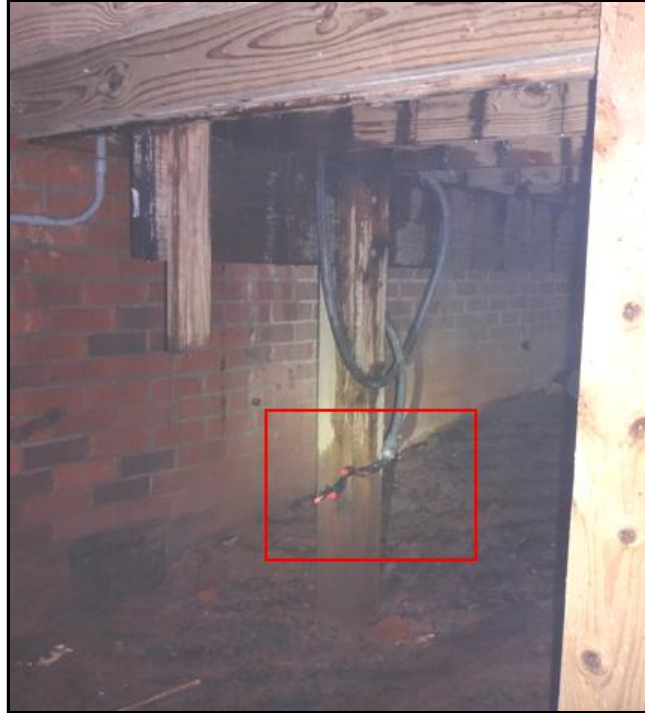
4.4 (Picture 1)

Unused hot tub circuit needs to terminate in a junction box - wires must not be left exposed (Picture 1)

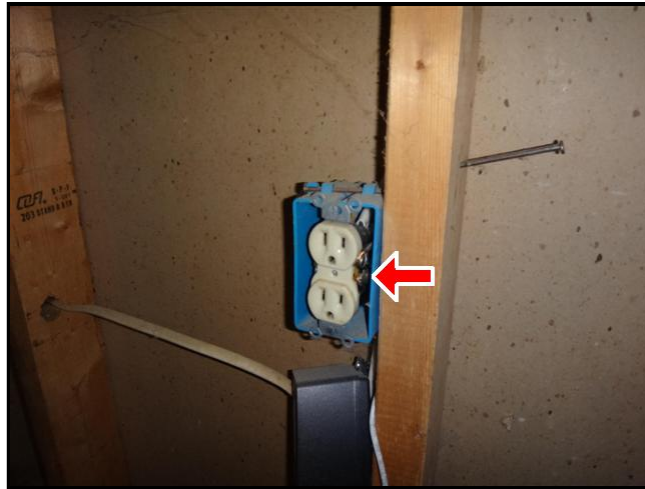
4.8 (Picture 1)

(1) Cover needed - utility/storage room (Picture 1)

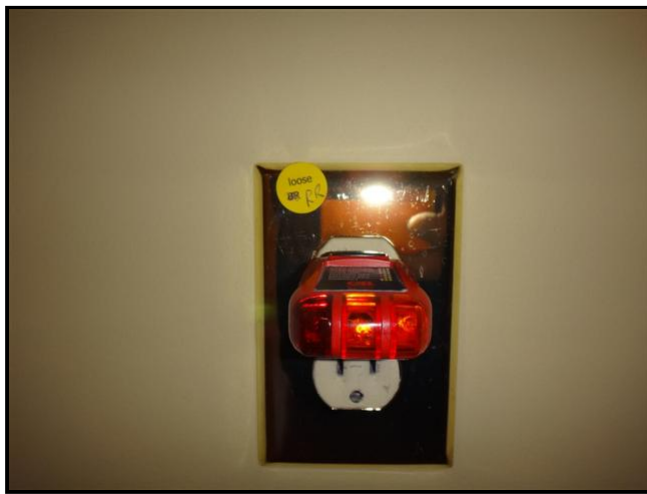
4.8 (Picture 2)

(2) Loose - rec room (Pictures 2, 3)

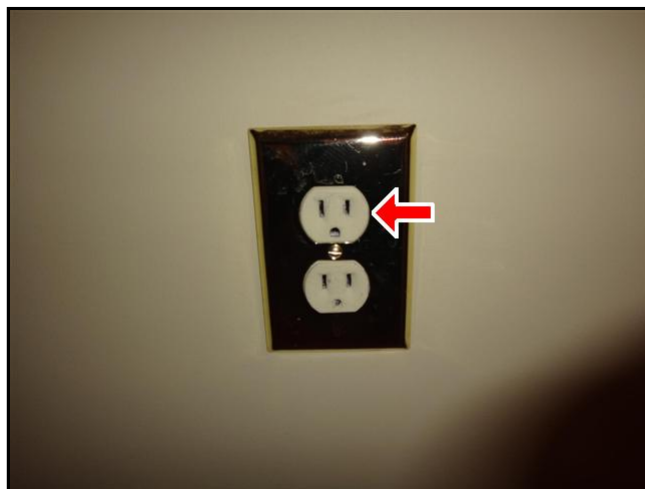
4.9 (Picture 1)

Replace all painted receptacles - paint can make receptacles difficult to use, and can impair the electrical connection - creating a fire hazard (Picture 1)

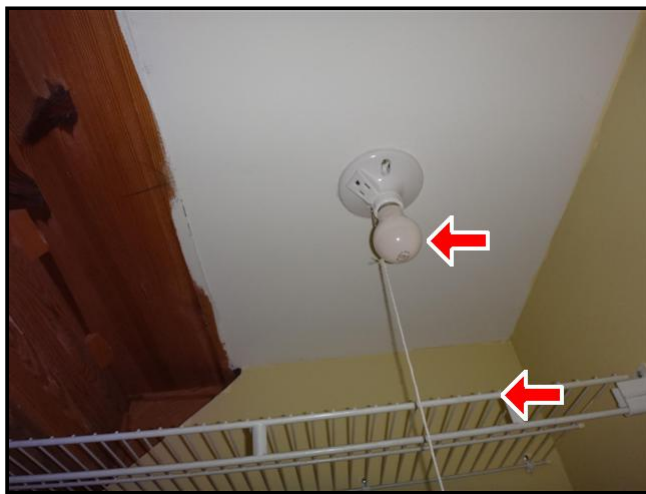
4.16 (Picture 1)

Replace all exposed closet fixtures with enclosed fixtures - fire hazard (Picture 1)(Picture 1)

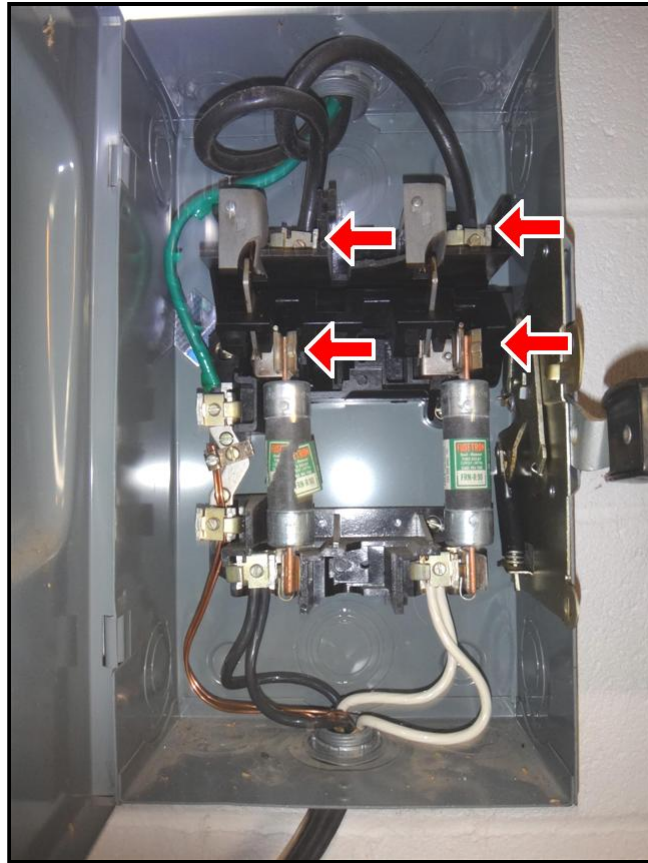
4.18 (Picture 1)

(1) Caution - electrical contact hazard - to be opened only by qualified personnel (Picture 1) (air handler service disconnect)

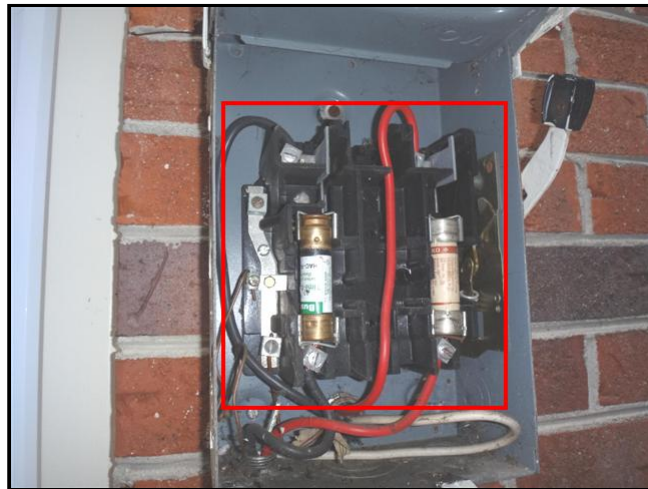
4.18 (Picture 2)

(2) Outdoor coil unit service disconnect - inner cover missing (Picture 2) - replace disconnect

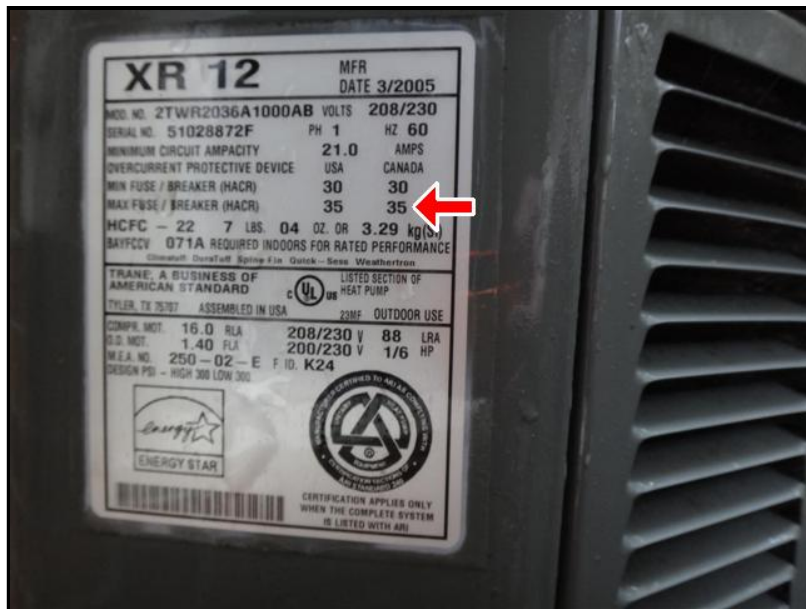
5.0 (Picture 1)

Outdoor coil unit overcurrent protection is overfused. Install properly sized fuses - see manufacturer's specifications on data tag (Pictures 1, 2)

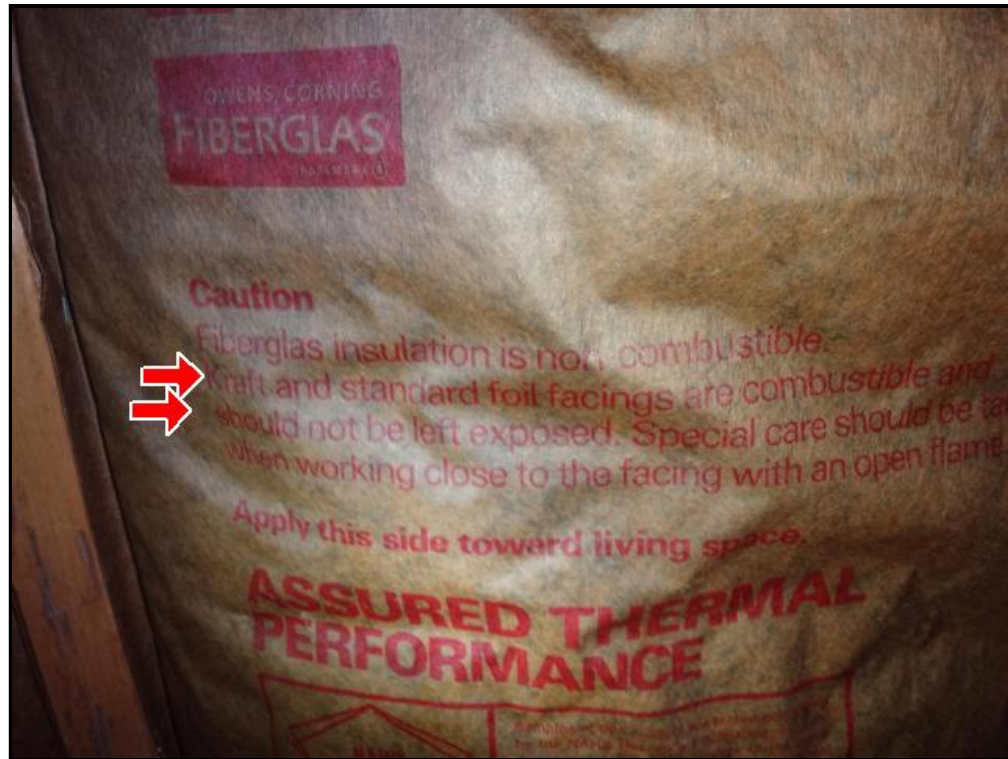
6.8 (Picture 1)

Kraft paper facing on insulation is flammable - contributes to flame spread - manufacturer requires paper facing be covered with an appropriate building material (Picture 1)

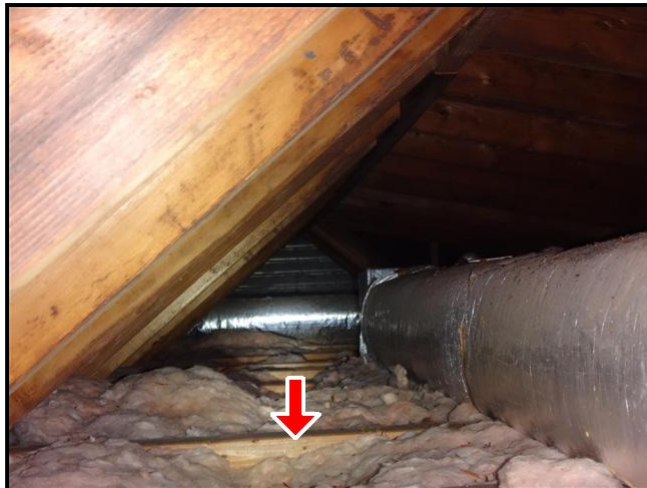
6.9 (Picture 1)

DoE recommends R-48 to R-60 for this climate zone (Pictures 1, 2) I recommend Southland Insulators 703.368.1965

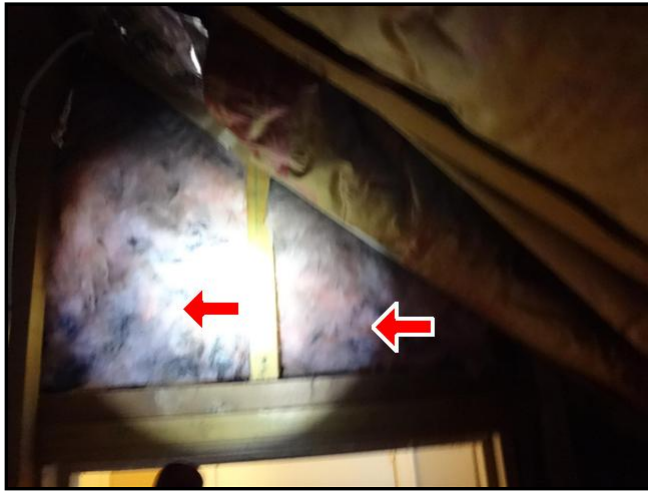
6.11 (Picture 1)

Insulation missing - knee walls (eave spaces) (Pictures 1, 2)

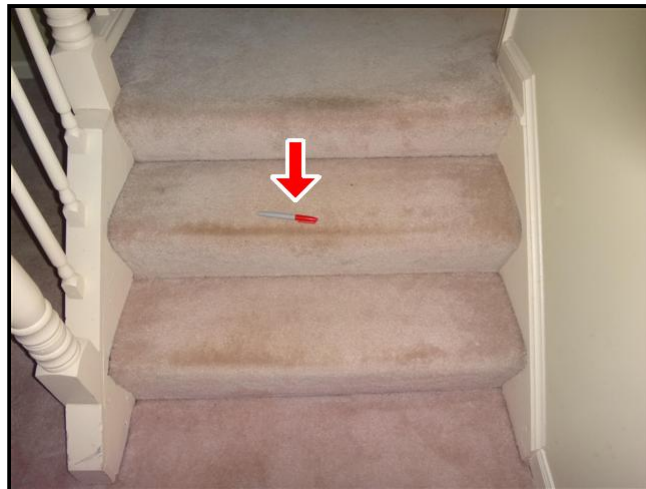
6.12 (Picture 1)

Loose step to recreation room (Picture 1)

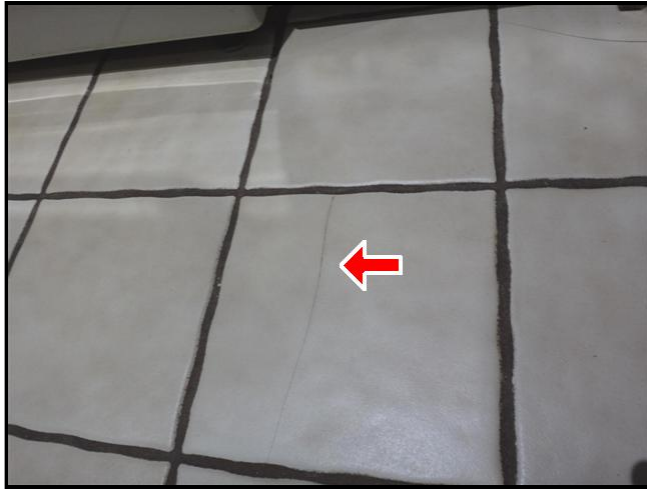
7.11 (Picture 1)

Cracked tiles are cosmetic (Pictures 1, 2)
