Inspection Report

1234 Main Street

HOMEAuthority

Date: 10/22/2014	Time: 02:00 PM	Report ID: RSmith
Property: 1234 Main Street City, VA 22209	Customer: RSmith	Real Estate Professional: J. Thompson

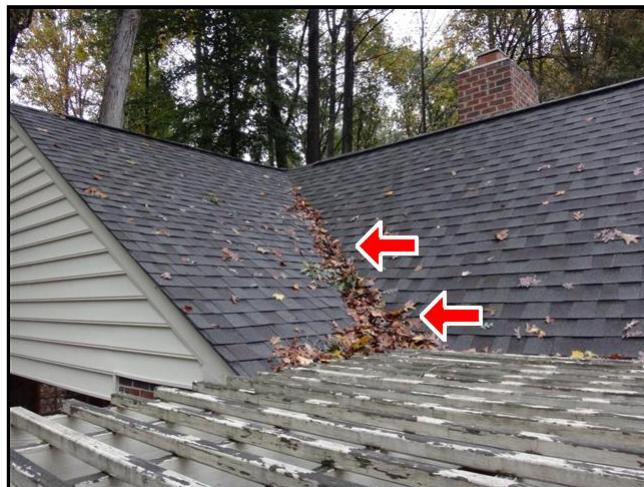
2.0 (Picture 1)

Valley needs to be cleaned periodically (Picture 1)

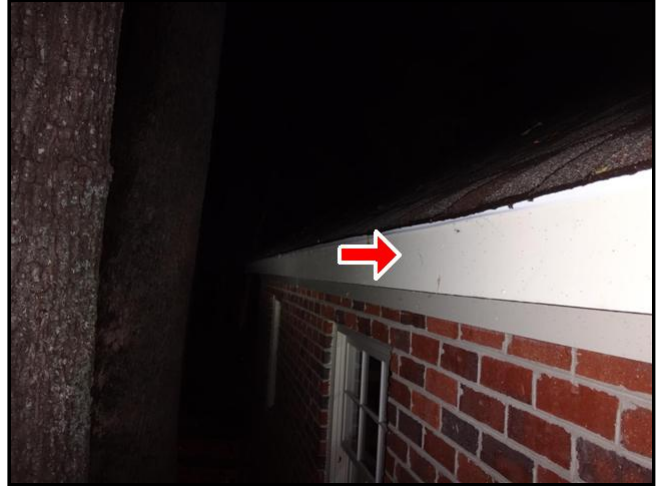
2.5 (Picture 2)

Recommend adding a gutter to the left side of the garage - use oversized gutter (Pictures 1, 2)

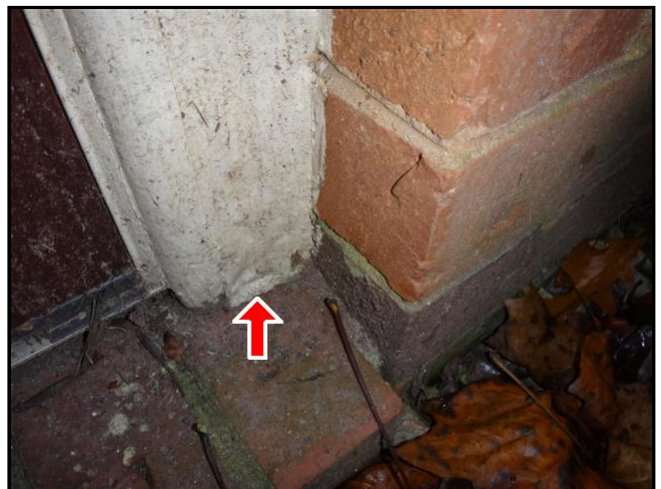
2.9 (Picture 2)

Minor rot at basement door (Pictures 1, 2)

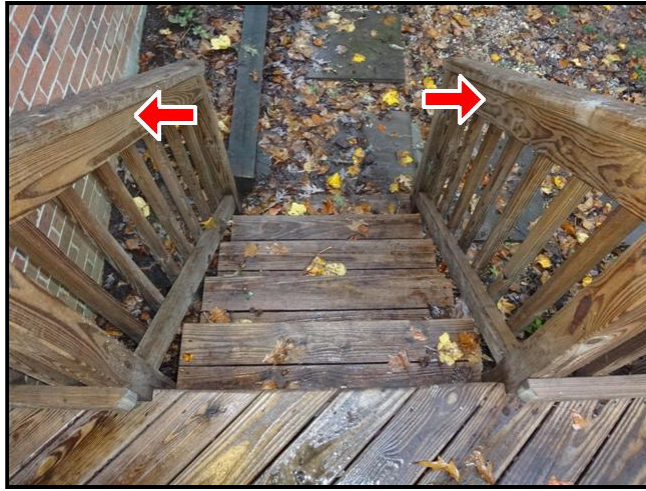
2.12 (Picture 1)

Major problem

There is no graspable handrail installed at the deck stairs (Picture 1)

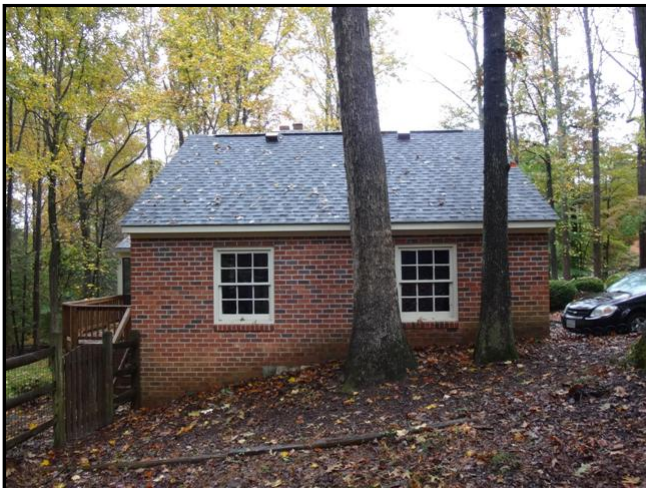
2.15 (Picture 1)

- (1) Have large trees near the house and garage checked by a licensed arborist
- (2) Consider removing the two trees next to the garage - they overhang the garage and house (Pictures 1, 2)

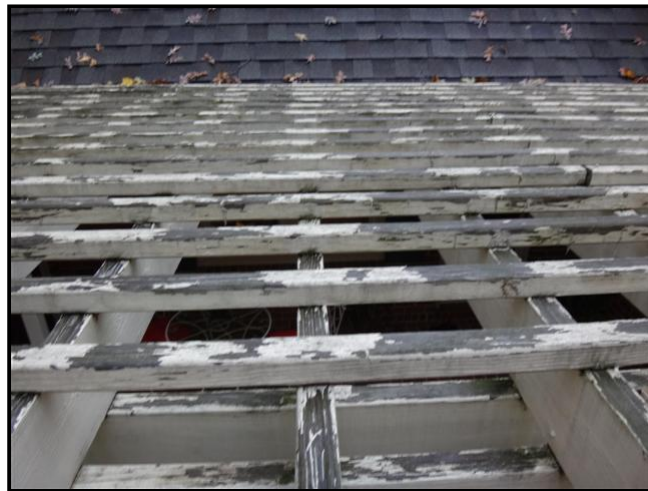
2.24 (Picture 3)

Keep top of pergola painted to prevent deterioration (Pictures 1 - 3)

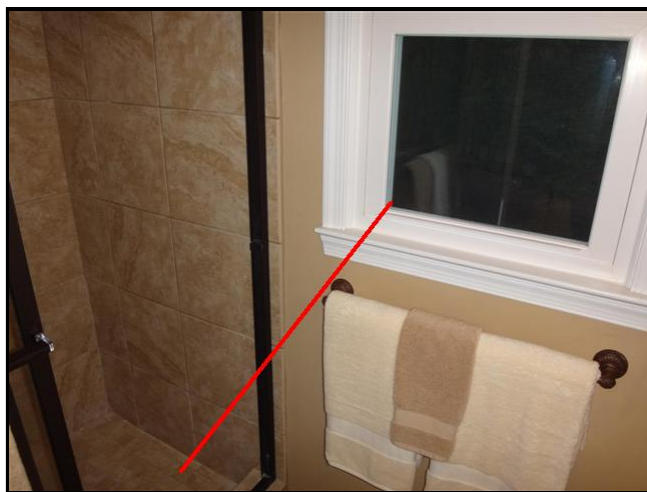
3.18 (Picture 2)

Windows in both main and upper level bathrooms need to be replaced with tempered/safety glass - both windows are within 60 inches of the tub and shower floors (Pictures 1, 2)

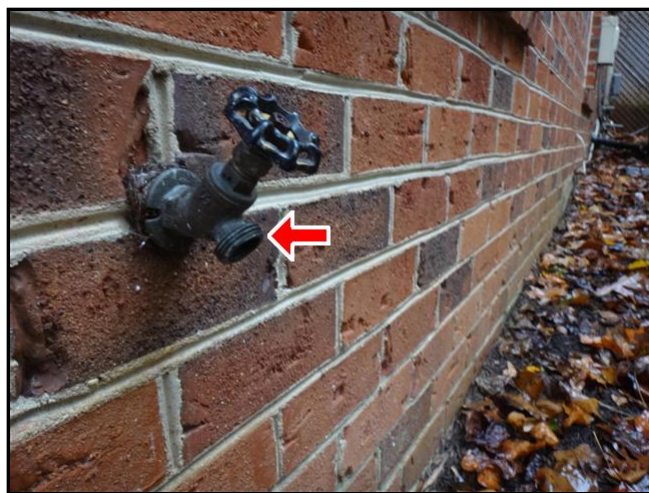
3.19 (Picture 1)

Major problem

The lack of hosebibb vacuum breakers compromises private water supply safety (Pictures 1, 2)

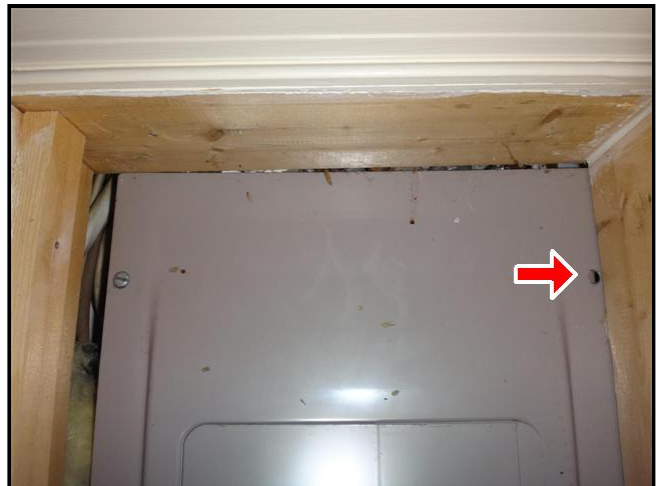
4.1 (Picture 2)

Panel cover screw(s) missing - replace only with manufacturer specific blunt tipped screw(s) (Pictures 1, 2)

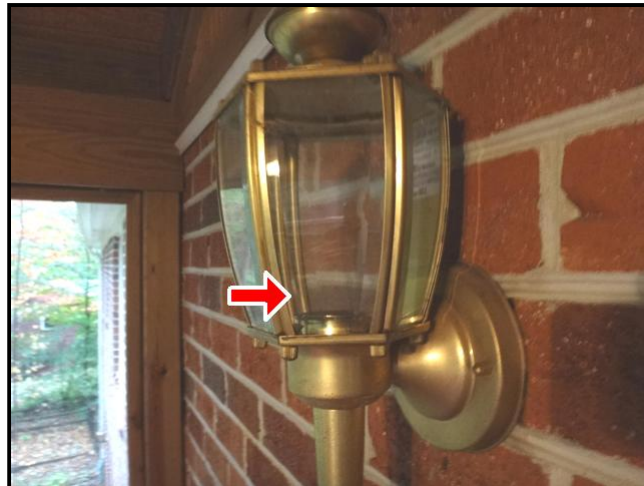
4.14 (Picture 1)

(1) Not checked - no bulb (Picture 1)

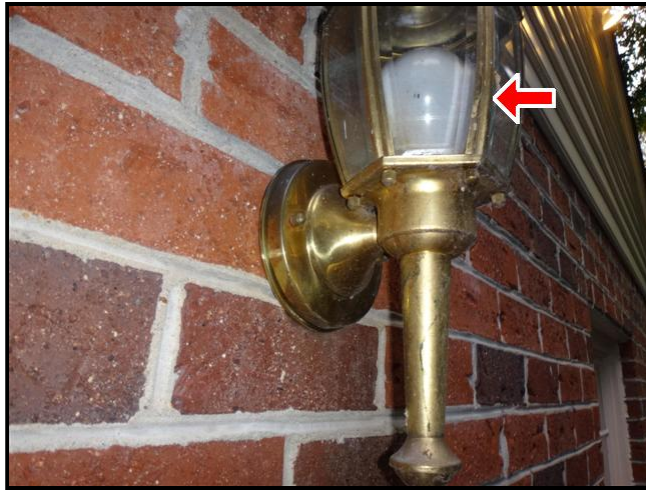
4.14 (Picture 2)

(2) Light out at deck (Picture 2)

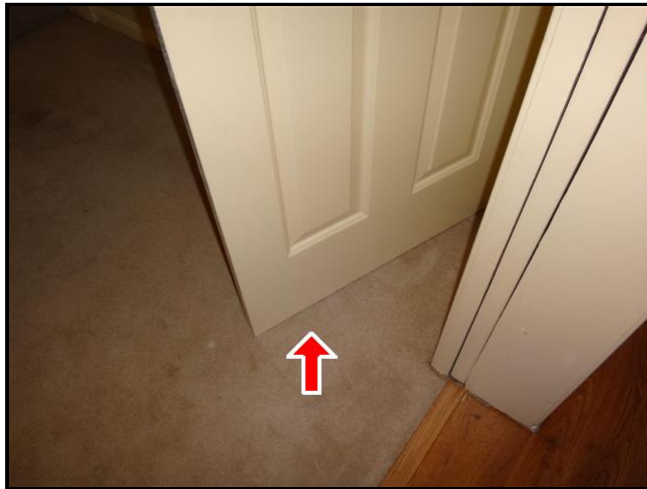
6.4 (Picture 1)

Minor problem

Undercut as needed to clear carpet (Pictures 1, 2)

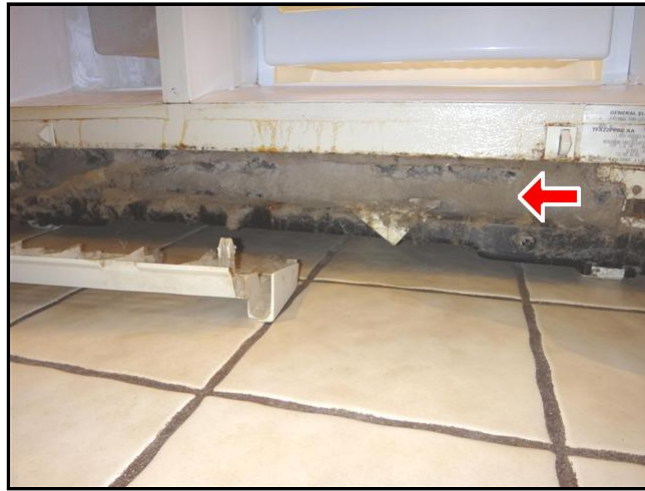
7.2 (Picture 1)

Minor problem

Clean coil under refrigerator with coil brush and vacuum three to four times per year (Picture 1)

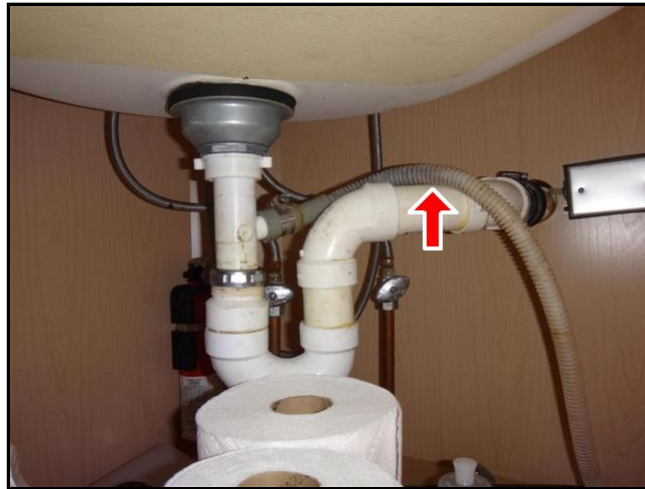
7.4 (Picture 1)

Minor problem

No air gap or vacuum breaker. Create a high loop in the dishwasher drain line between the dishwasher and the disposer or drain. The high loop must be secured directly under the counter top to prevent a plumbing back up from siphoning into the dishwasher (Picture 1)

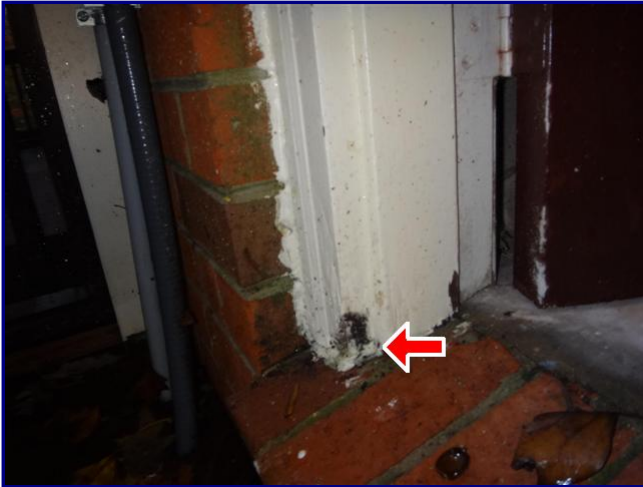
2.9

Minor problem

Minor rot at basement door (Pictures 1, 2)

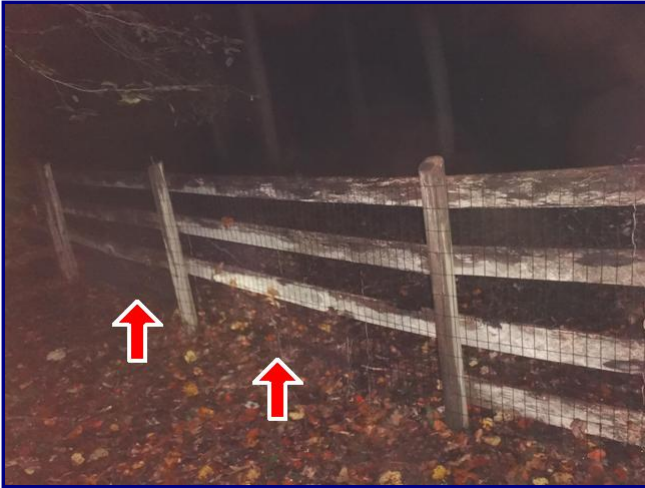
2.17

Fence needs repairs - budget to replace (Pictures 1, 2)

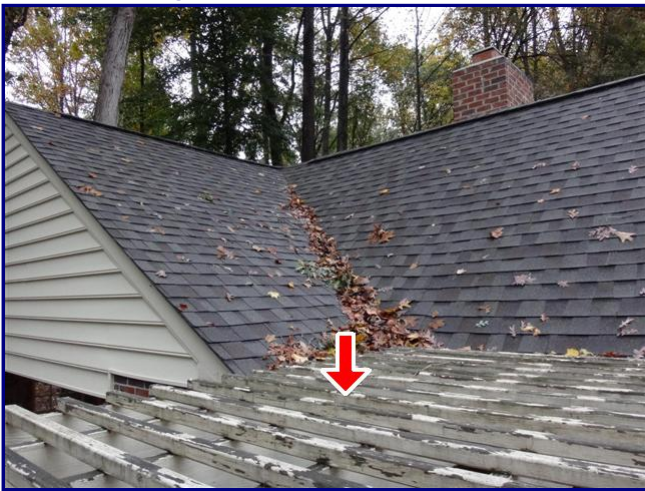
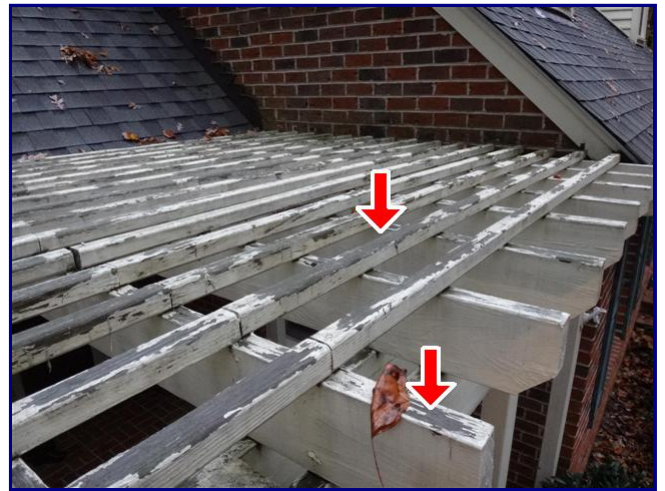
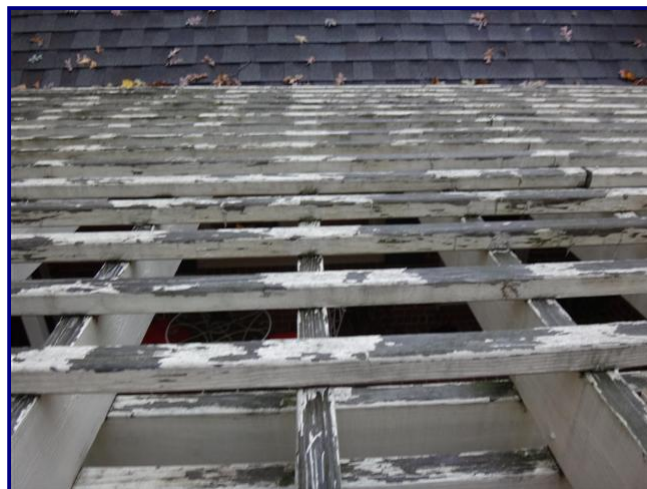
Keep top of pergola painted to prevent deterioration (Pictures 1 - 3)

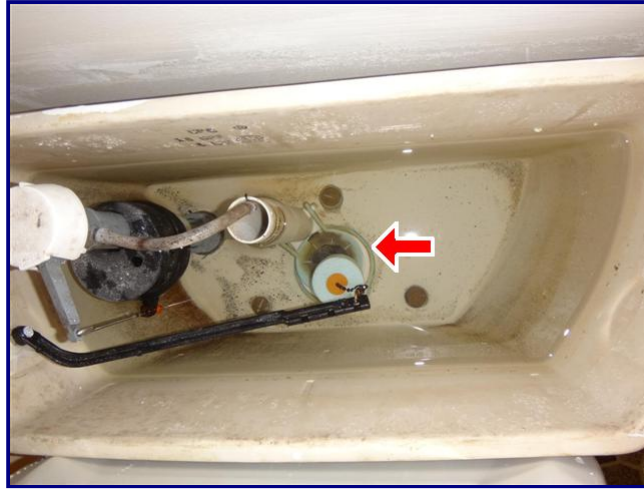
3.2

Basement toilet runs - replace tank flapper (Picture 1)

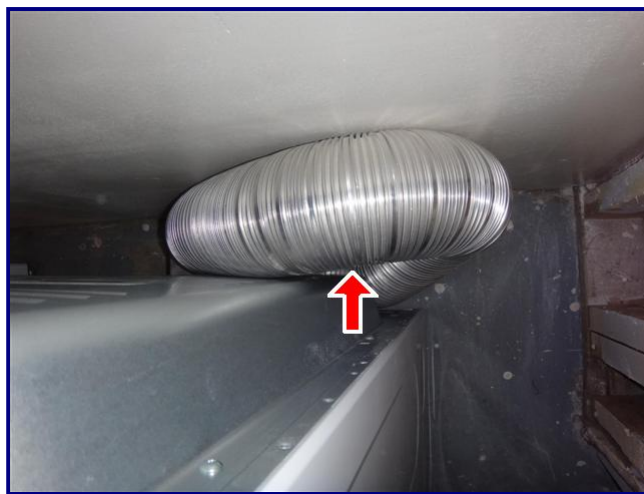
3.6

Dryers, vent ducts and vent outlets must be professionally cleaned periodically - fire hazard (Picture 1)

Although flexible metal pipe is approved, it is not preferred - recommend replacing with solid aluminum dryer vent pipe - always use the shortest possible amount of pipe with the fewest possible turns and bends (Picture 1)

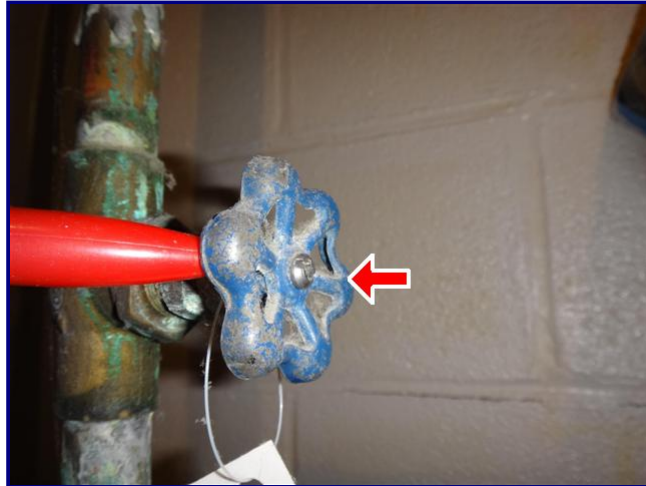
3.10

Water heater valve is seized - replace with a ball/90 degree valve (Picture 1)

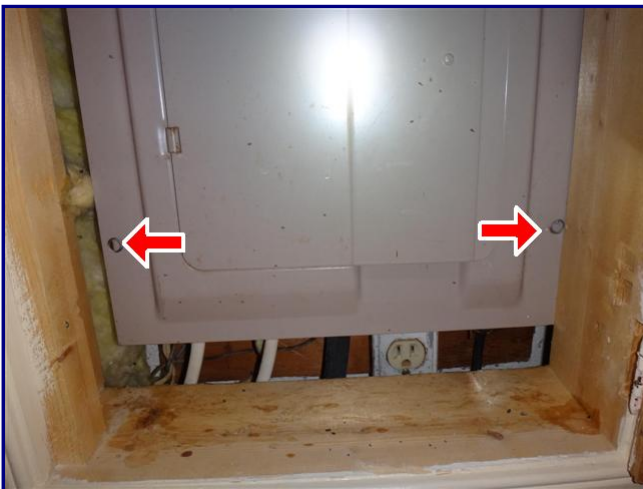
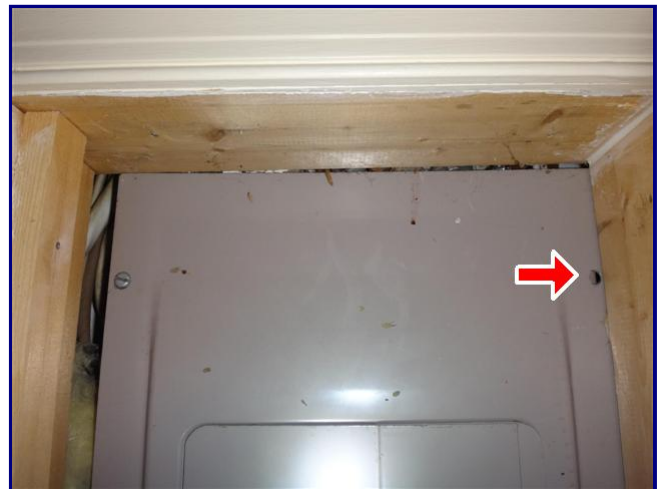
Panel cover screw(s) missing - replace only with manufacturer specific blunt tipped screw(s) (Pictures 1, 2)

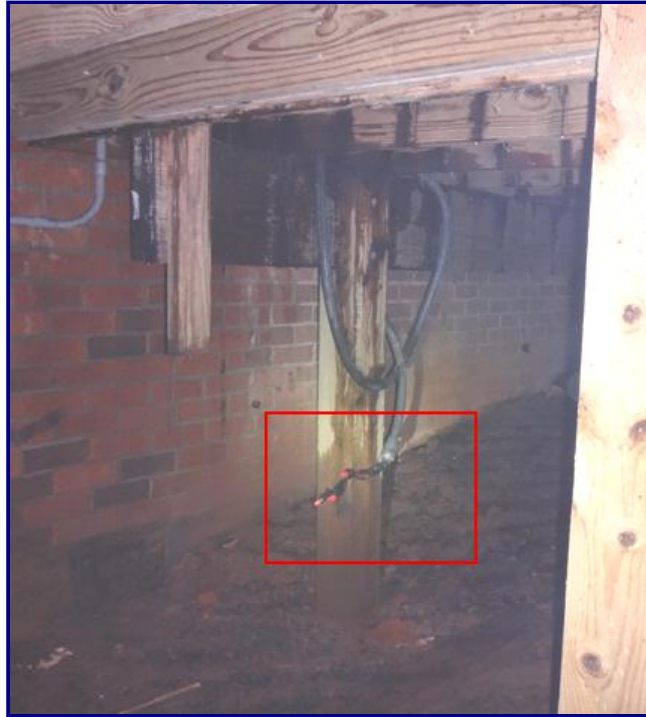
4.4

Unused hot tub circuit needs to terminate in a junction box - wires must not be left exposed (Picture 1)

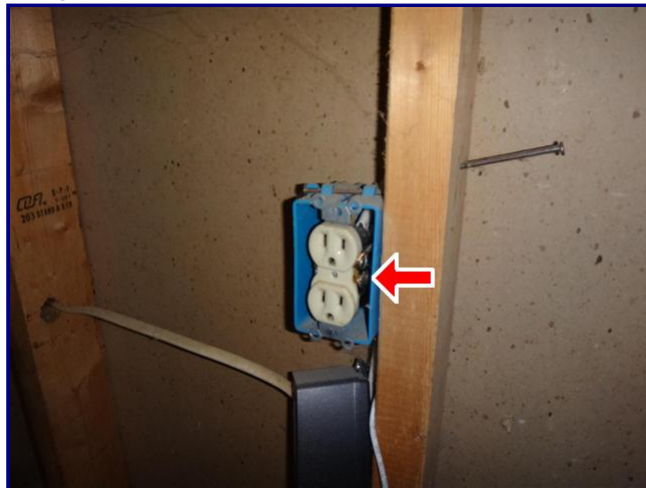
4.8

(1) Cover needed - utility/storage room (Picture 1)

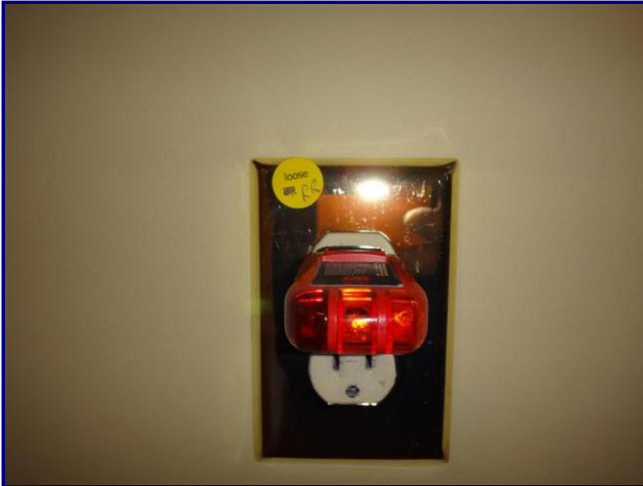
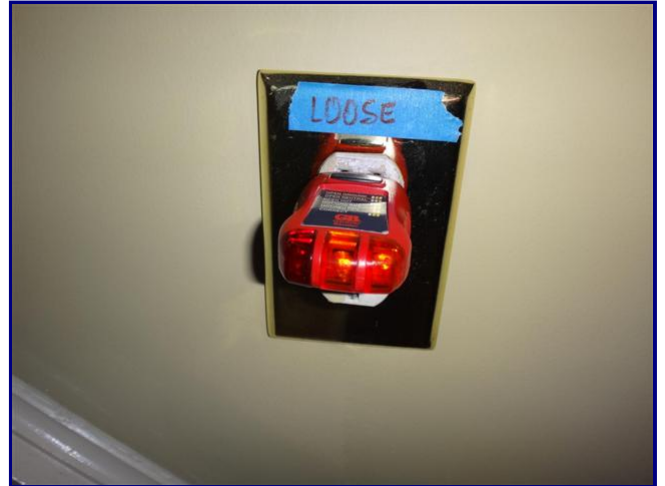
(2) Loose - rec room (Pictures 2, 3)

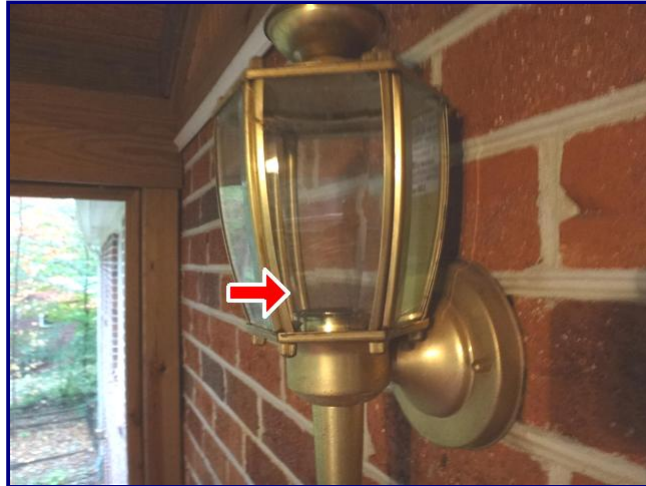
4.14

(1) Not checked - no bulb (Picture 1)

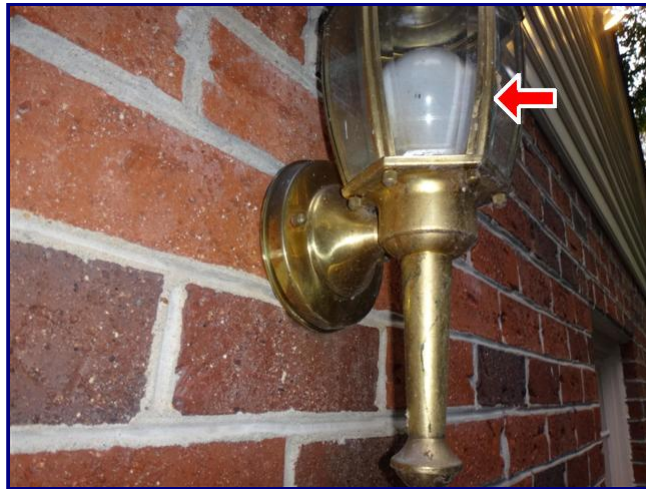
4.14

(2) Light out at deck (Picture 2)

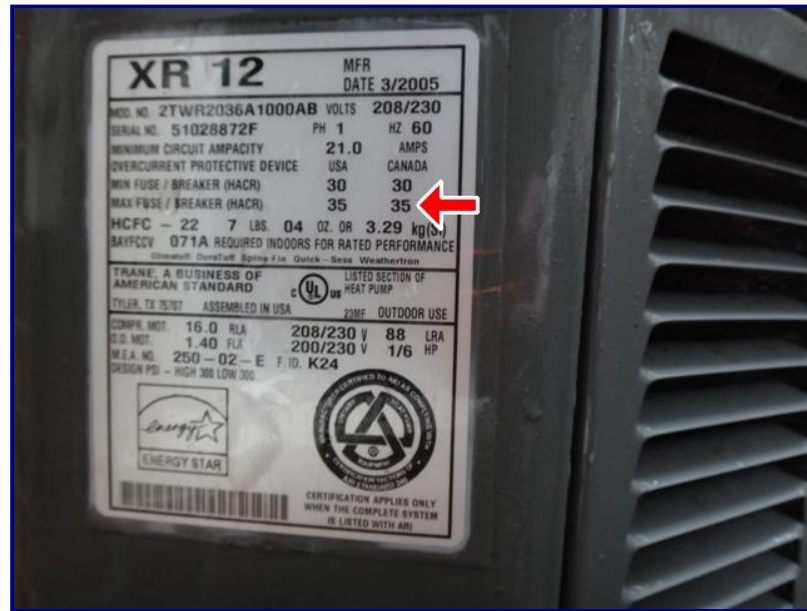
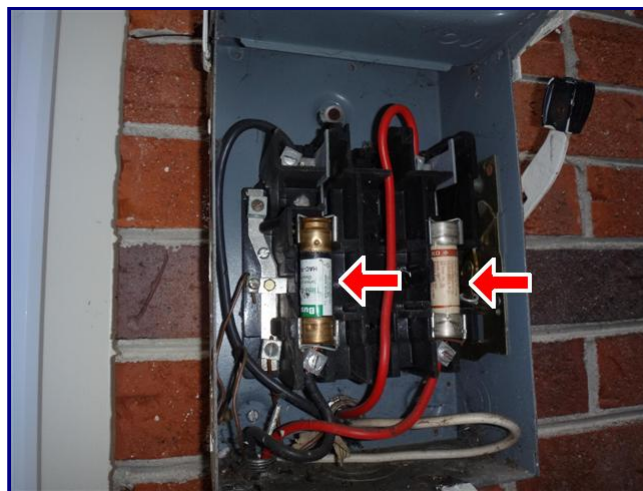
Outdoor coil unit overcurrent protection is overfused. Install properly sized fuses - see manufacturer's specifications on data tag (Pictures 1, 2)

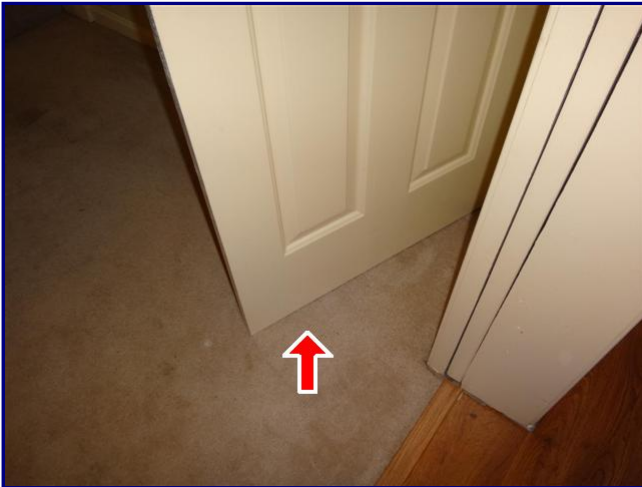
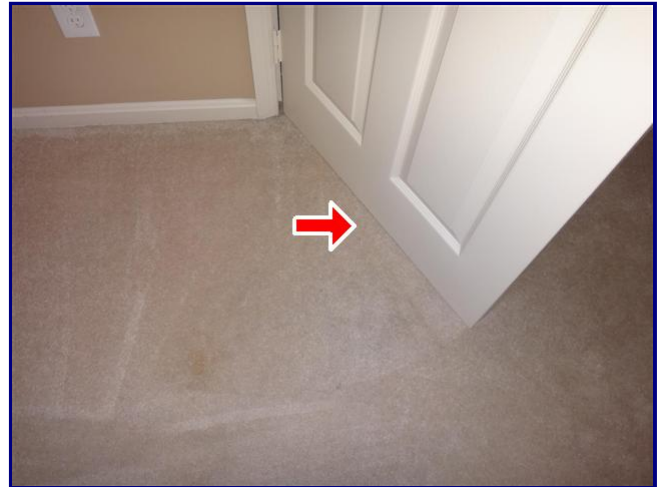
Undercut as needed to clear carpet (Pictures 1, 2)

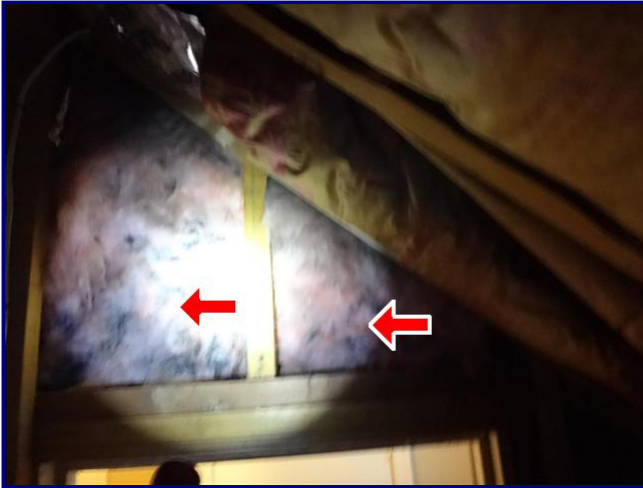
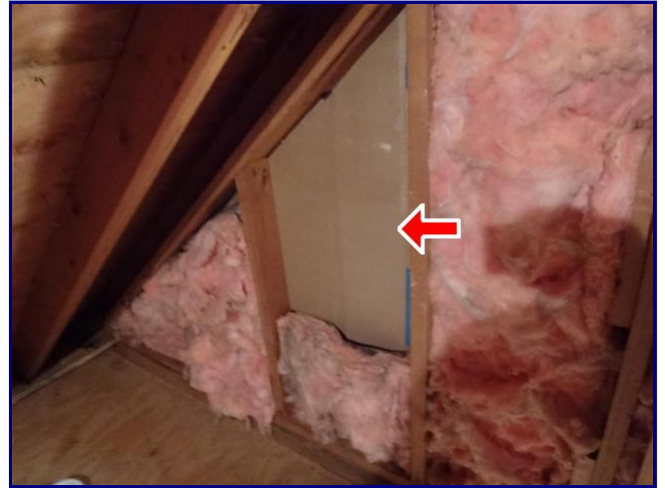
Insulation missing - knee walls (eave spaces) (Pictures 1, 2)

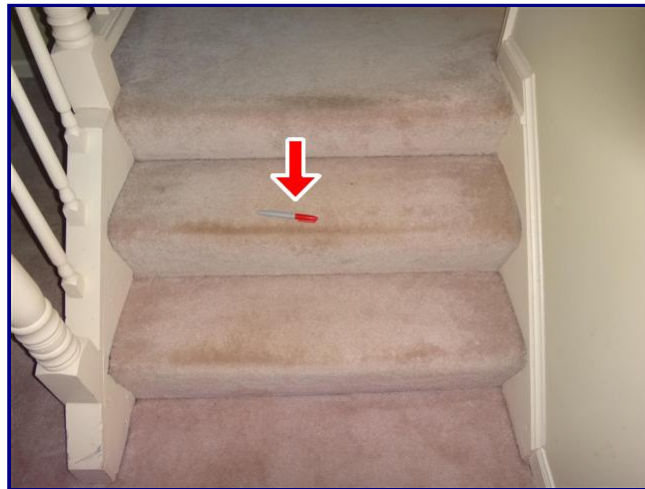
6.12

Loose step to recreation room (Picture 1)

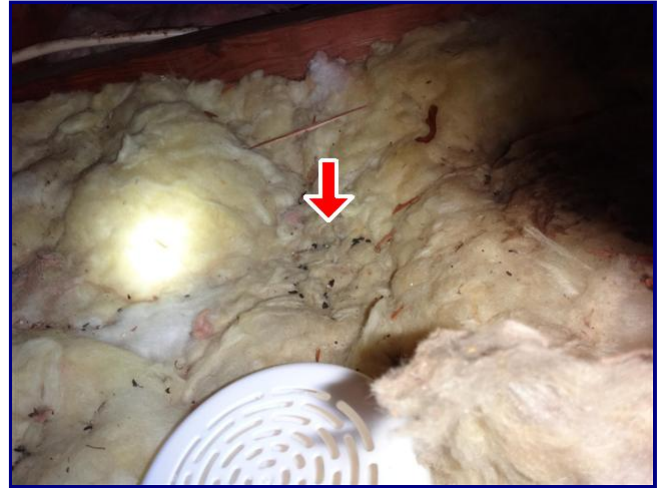
Evidence of mice at electric panel and in attic (Pictures 1, 2)

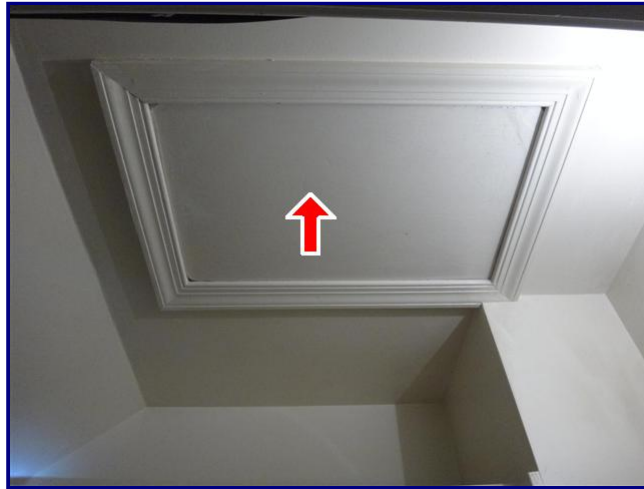
6.18

Replace attic hatch cover with 2 pieces 5/8" MDF (medium density fiberboard) glued together, with 8" foam board glued on top of the MDF - clean trim around hatch opening and apply 3/4" wide adhesive backed EPDM weatherstrip to the trim and the hatch cover (Picture 1)

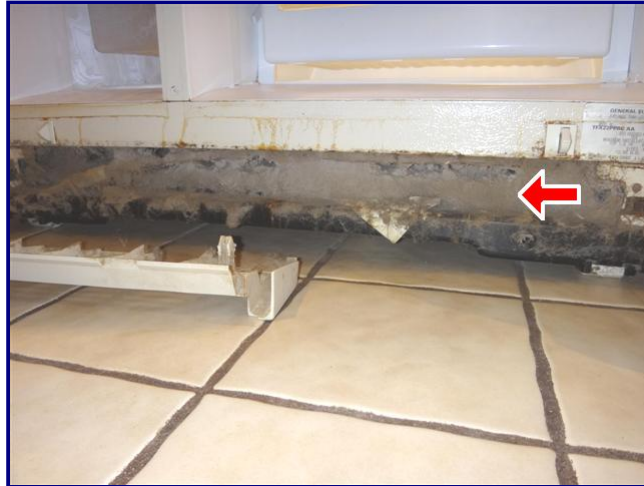
7.2

Clean coil under refrigerator with coil brush and vacuum three to four times per year (Picture 1)

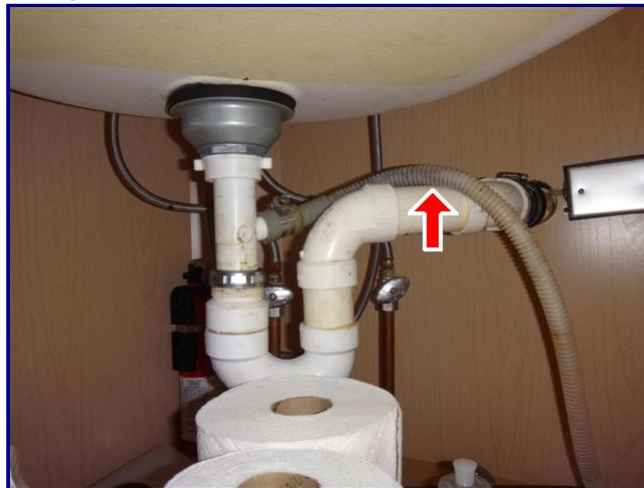
7.4

No air gap or vacuum breaker. Create a high loop in the dishwasher drain line between the dishwasher and the disposer or drain. The high loop must be secured directly under the counter top to prevent a plumbing back up from siphoning into the dishwasher (Picture 1)

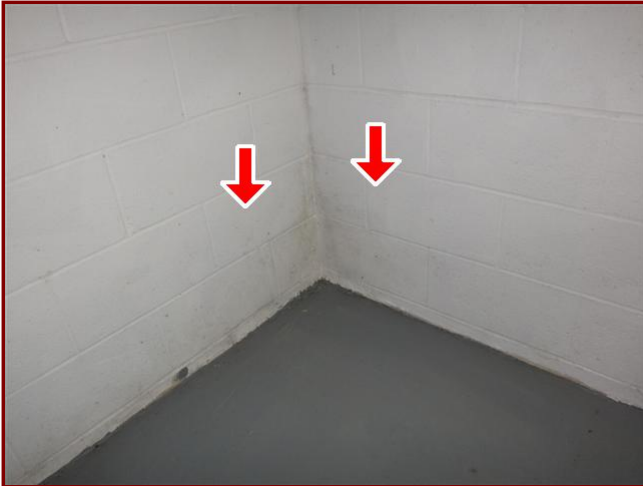
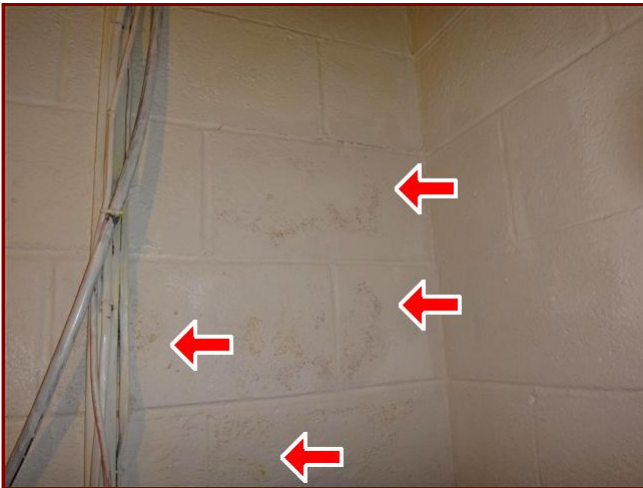
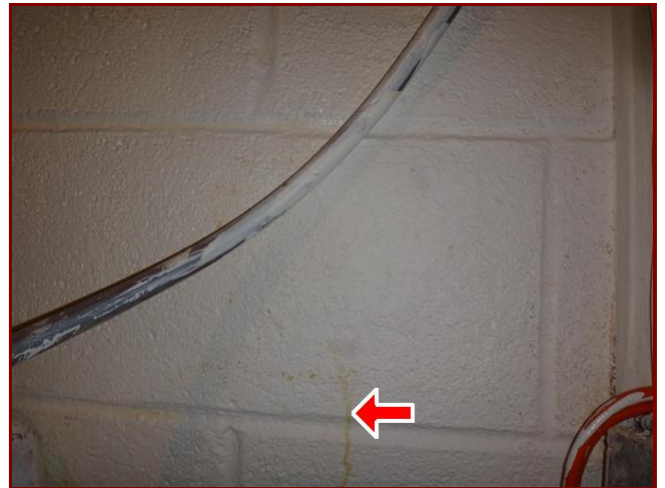
Provide a positive flow of surface water away from foundation walls - efflorescence, peeling paint, stains are all evidence of dampness (Pictures 1 - 4)

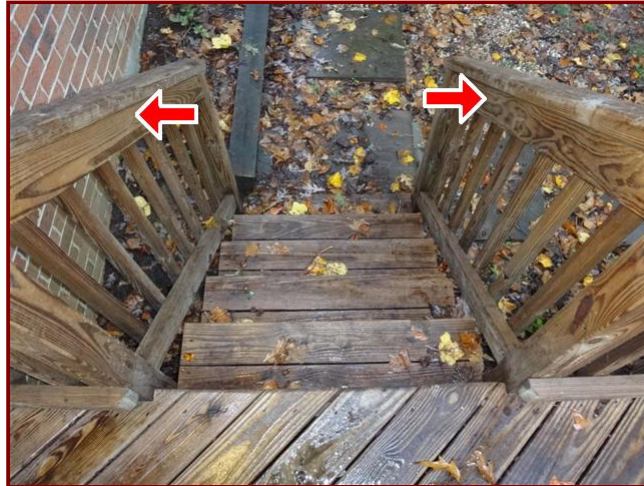
2.12

There is no graspable handrail installed at the deck stairs (Picture 1)

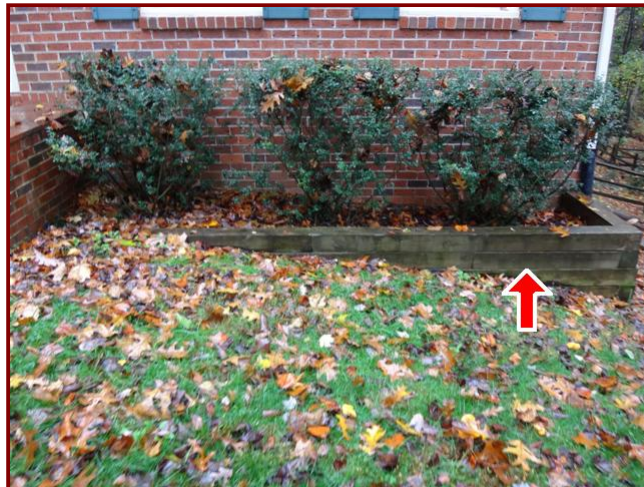
2.16

Provide a positive flow of surface water away from foundation walls - ground needs to slope away from foundation with at least an inch of fall per foot for at least eight feet. When this is not possible, install French drain(s) (Picture 1)

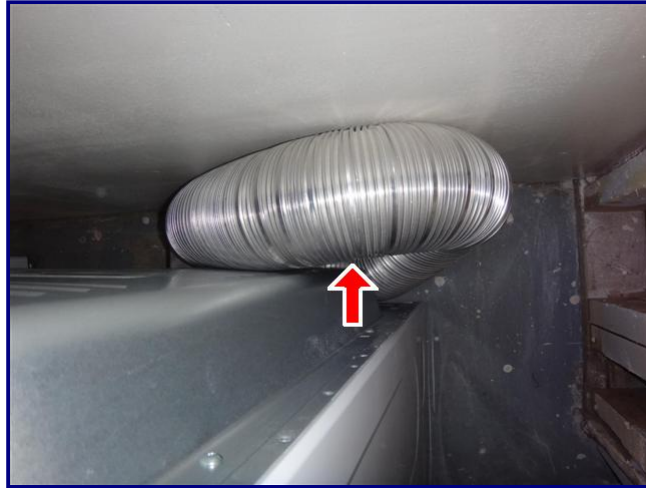
3.6

Dryers, vent ducts and vent outlets must be professionally cleaned periodically - fire hazard (Picture 1)

Although flexible metal pipe is approved, it is not preferred - recommend replacing with solid aluminum dryer vent pipe - always use the shortest possible amount of pipe with the fewest possible turns and bends (Picture 1)

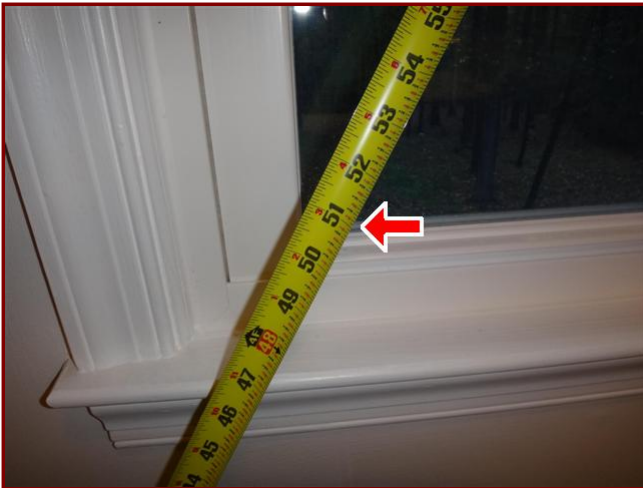
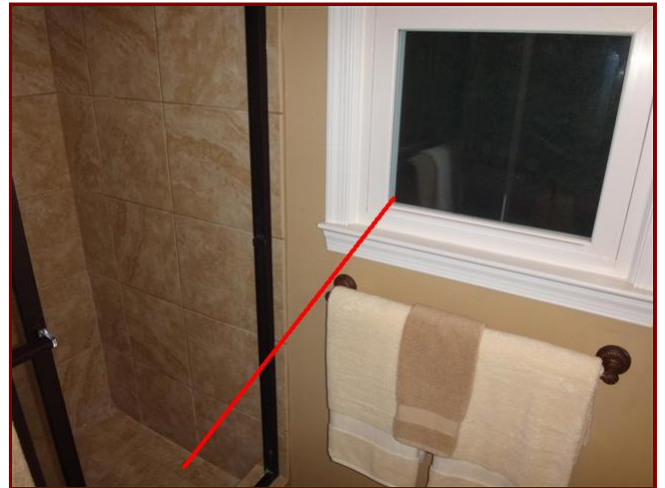
Windows in both main and upper level bathrooms need to be replaced with tempered/safety glass - both windows are within 60 inches of the tub and shower floors (Pictures 1, 2)

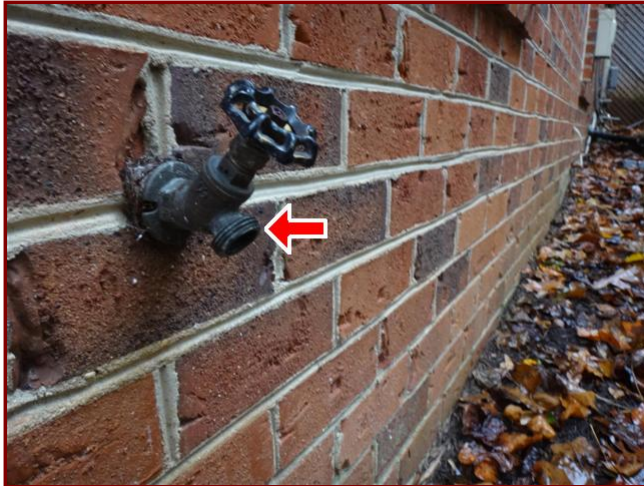
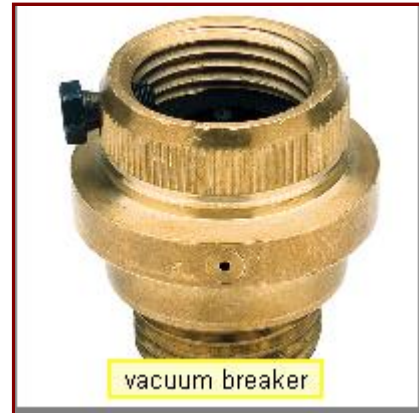
The lack of hosebibb vacuum breakers compromises private water supply safety (Pictures 1, 2)

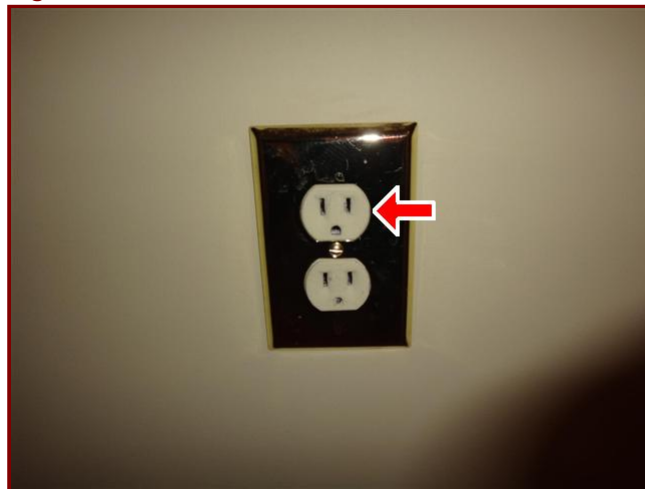
4.9

Replace all painted receptacles - paint can make receptacles difficult to use, and can impair the electrical connection - creating a fire hazard (Picture 1)

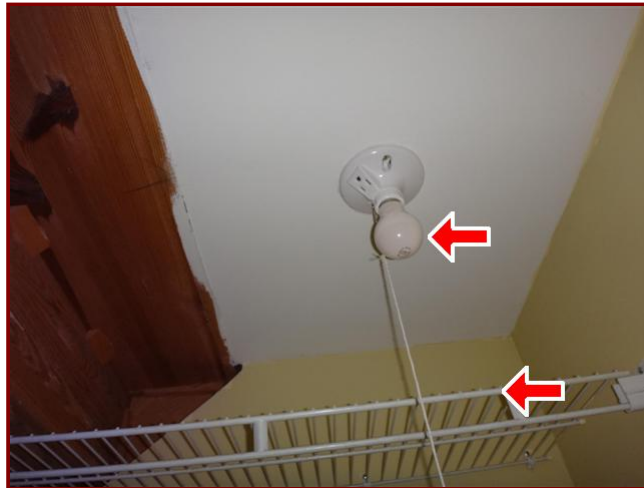
4.16

Replace all exposed closet fixtures with enclosed fixtures - fire hazard (Picture 1)(Picture 1)

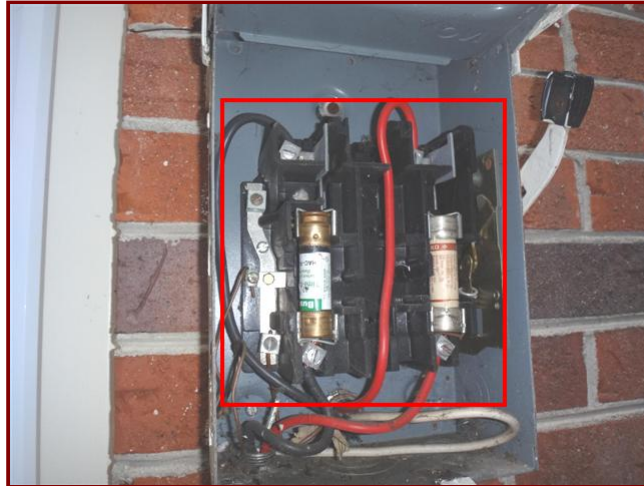
4.18

(2) Outdoor coil unit service disconnect - inner cover missing (Picture 2) - replace disconnect

I highly recommend [Mannix HVAC 703.777.9211](tel:703.777.9211)

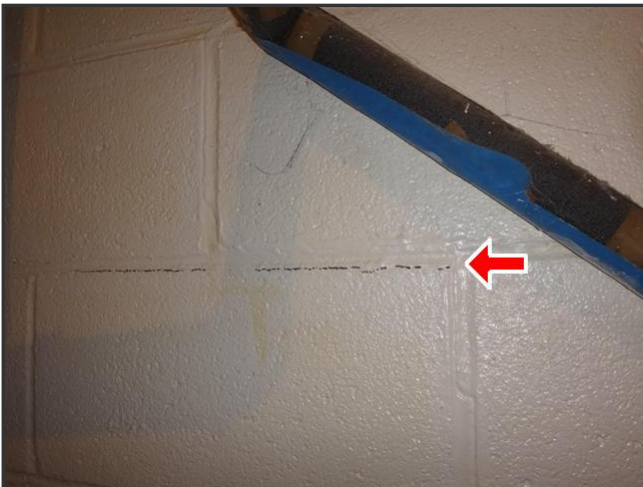
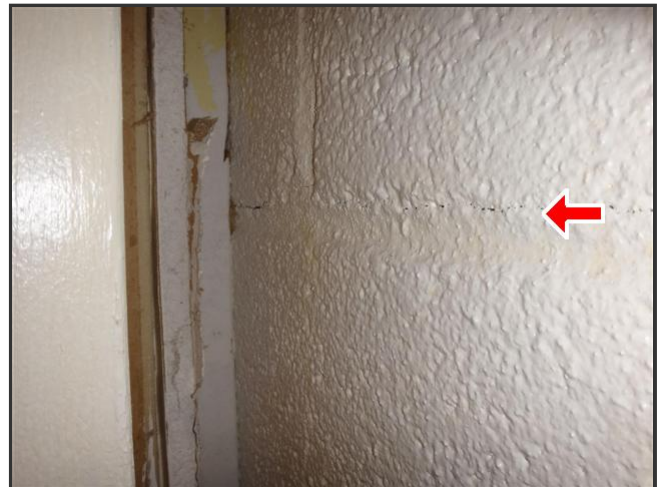
Horizontal cracks in foundation wall are typically caused by hydrostatic pressure - water in the ground pushing against the wall. The house is below street level - improve and maintain surface water controls (Pictures 1, 2)

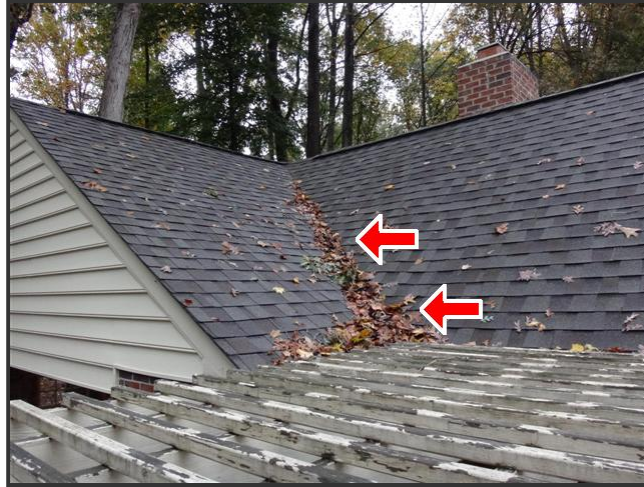
2.0

Valley needs to be cleaned periodically (Picture 1)

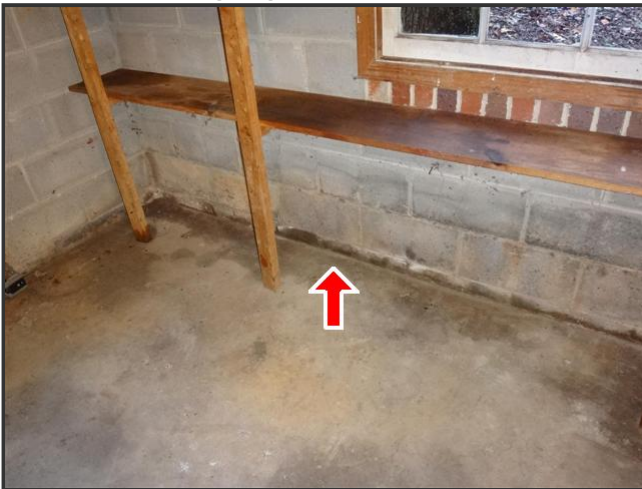
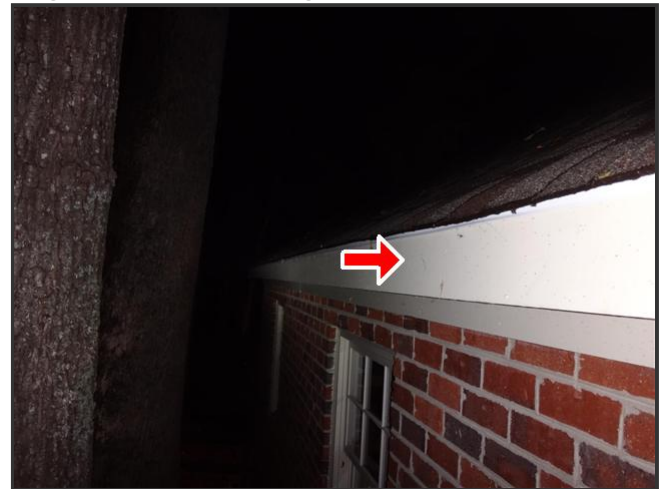
Recommend adding a gutter to the left side of the garage - use oversized gutter (Pictures 1, 2)

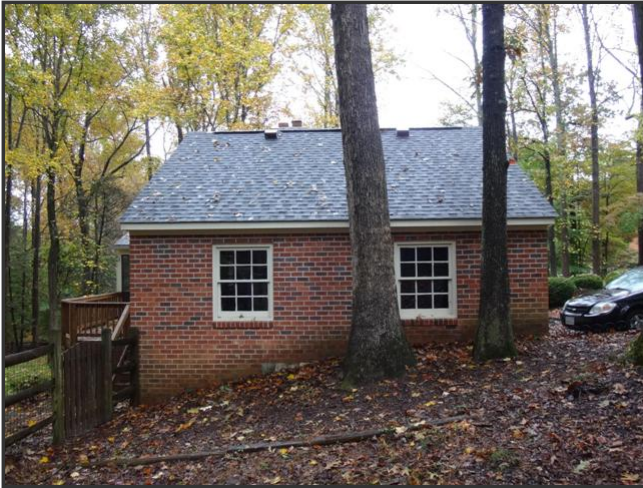
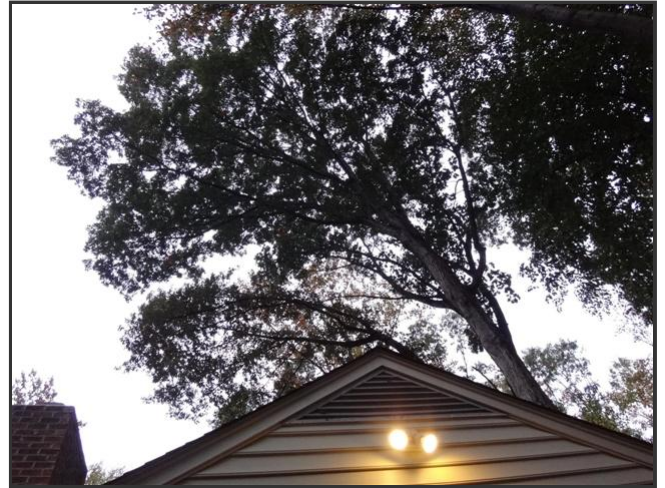
- (1) Have large trees near the house and garage checked by a licensed arborist
- (2) Consider removing the two trees next to the garage - they overhang the garage and house (Pictures 1, 2)

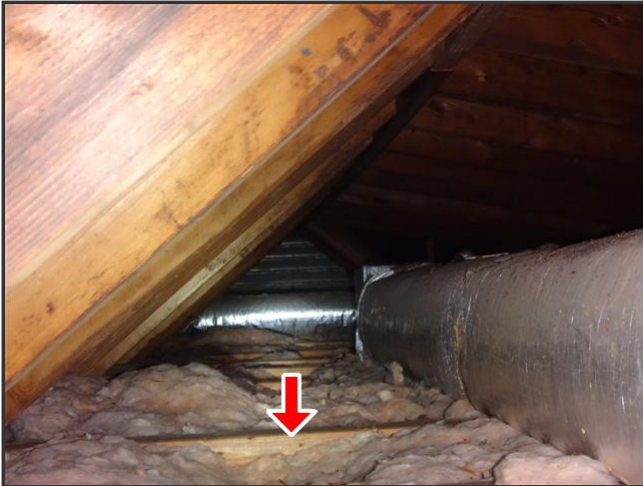
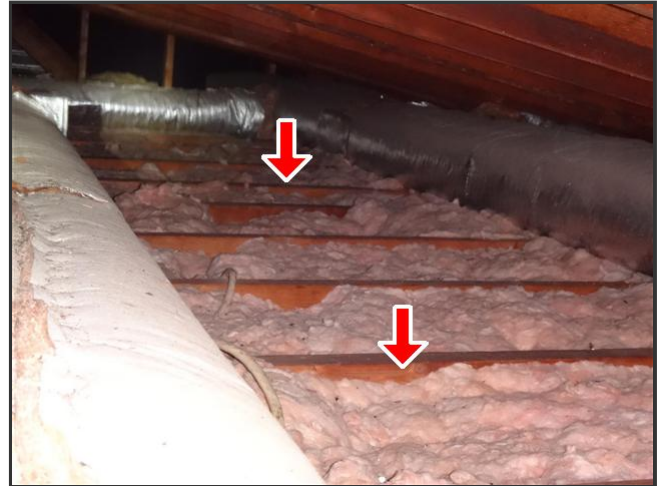
DoE recommends R-48 to R-60 for this climate zone (Pictures 1, 2) I recommend [Southland Insulators](http://SouthlandInsulators.com) 703.368.1965

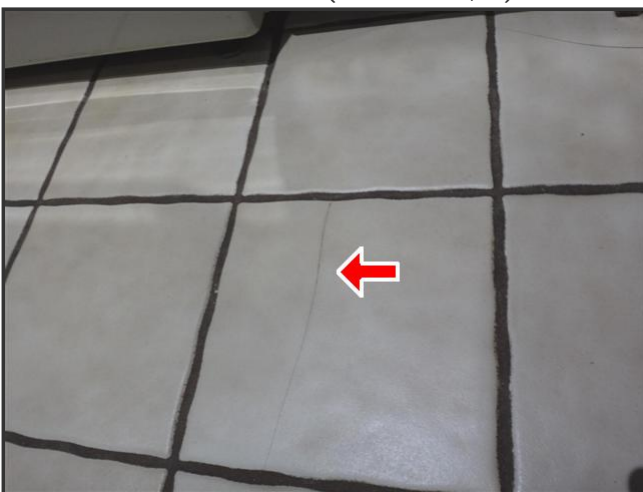
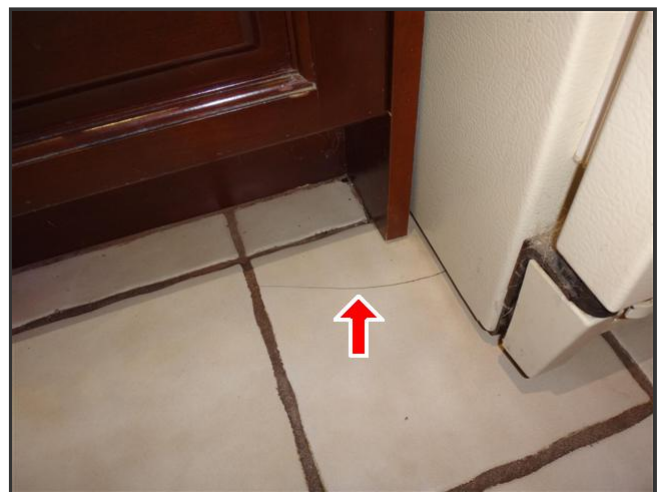
Cracked tiles are cosmetic (Pictures 1, 2)
